Manhole Inspection Summary

Manhole # S43WW_001MH

Insp Date: **2/16/07 2:12 PM**

Location Address: **2819 THE ALAMEDA**

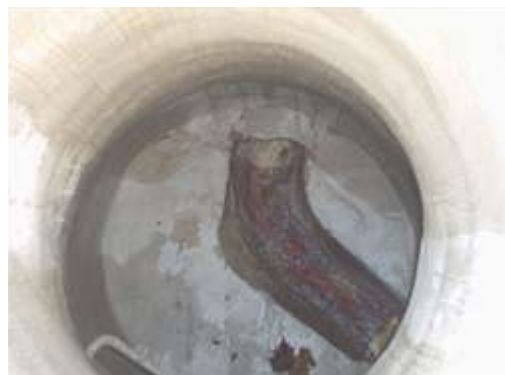
Top View

Infiltration: ☐ None ☒ **Joint** ☐ Cracks ☐ Mortar ☐ Roots ☒ **Wall**

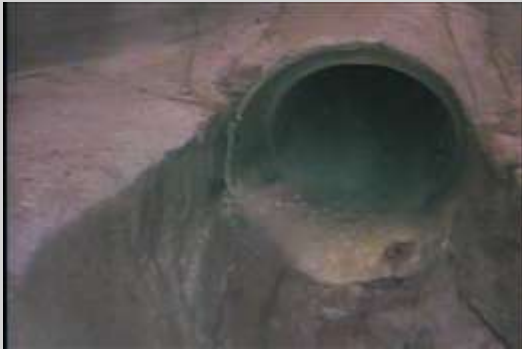
10 in. Circular Gravity Sewer Pipe Out @ 12 O'Clock

Pipe Material: **Unknown** ☒ Pipe Lined

Invert Depth: **7.68** (ft.) Flow Characteristics: **Slow**

Infiltration: **None** Pipe Seal Cond: **Unknown**

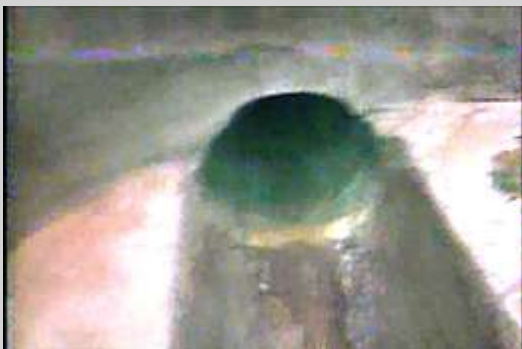
10 in. Circular Gravity Sewer Pipe In @ 4 O'Clock

Pipe Material: **Unknown** ☒ Pipe Lined

Invert Depth: **7.21** (ft.) Flow Characteristics: **Slow**

Infiltration: **None** Pipe Seal Cond: **Unknown**
